## Release history for Model numbers PM5341

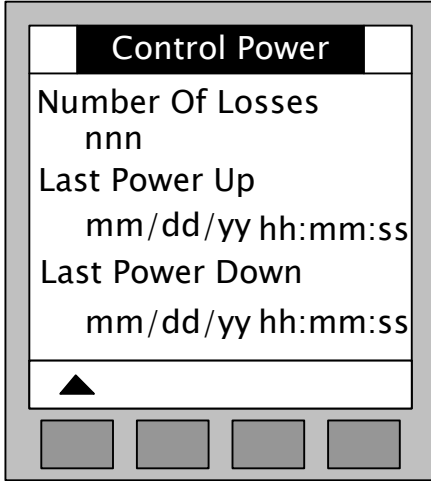
<ul style="list-style-type: none"> <li>Following screen is added in the control power menu</li> </ul>
