## Fixed USB port for VAMP 50 and VAMP 300 series relays

This application note applies to Vamp 50 and Vamp 300 series

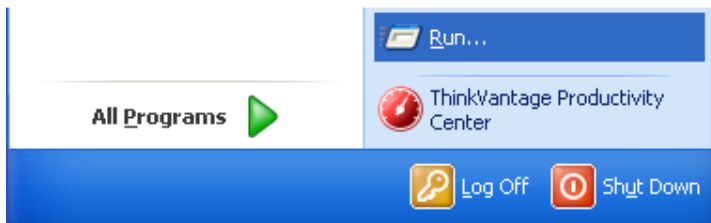
### Step 1.

Go to: start → run

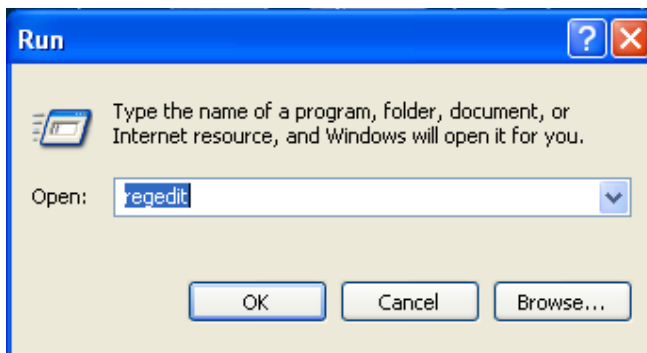
### Step 2.

Write: regedit

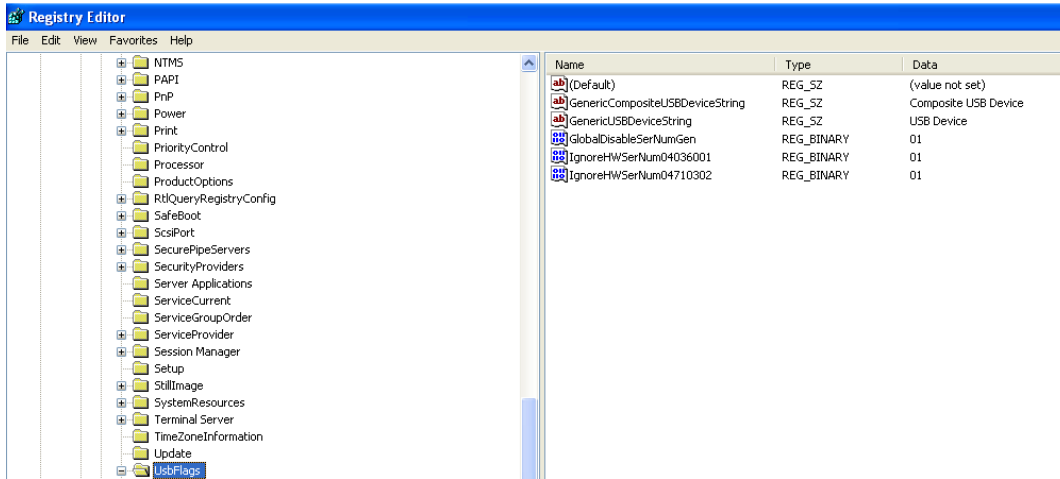
### Step 3.

Go to: HKEY\_LOCAL\_MACHINE→SYSTEM→CurrentControlSet→Control→UsbFlags

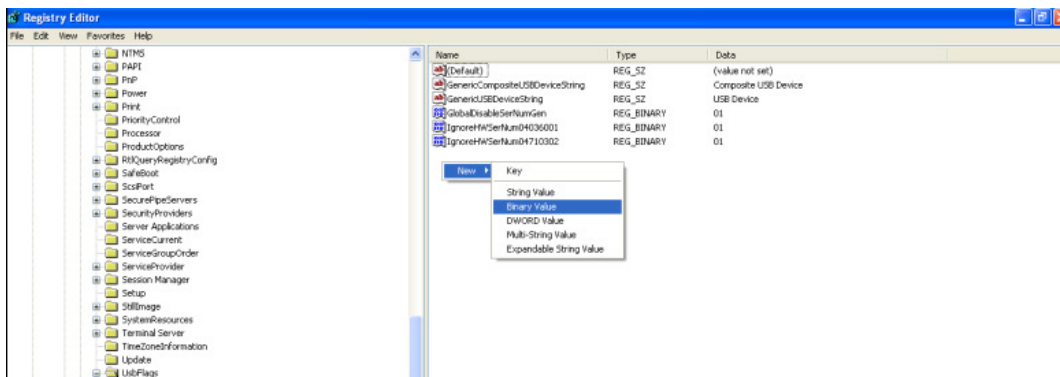
### Step 4.

Press right mouse button and add new Binary Value.

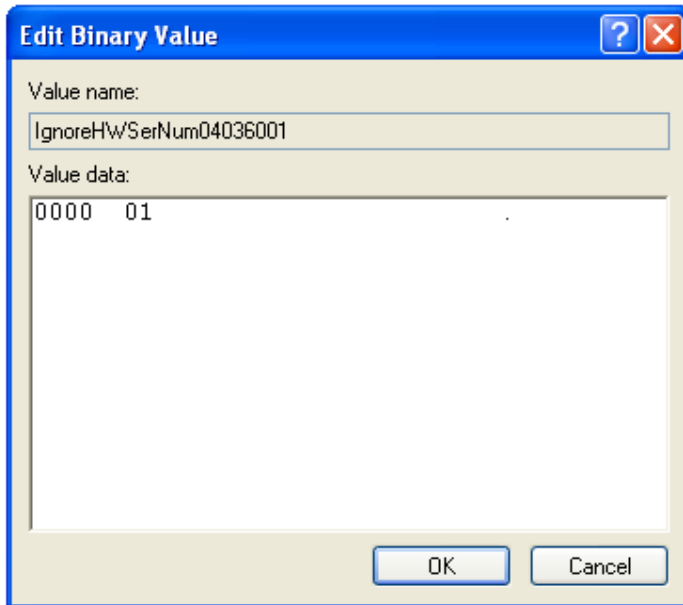
**Step 5.**

Name this binary value as: IgnoreHWSerNum04036001 and give value 01 to it.

IgnoreHWSerNum04036001	REG_BINARY	01

IgnoreHWSerNum04710302	REG_BINARY	01
