EcoStruxure Machine Expert - HVAC

Release Notes

RN0000000007.07

Release Notes EcoStruxure Machine Expert – HVAC v1.2.1

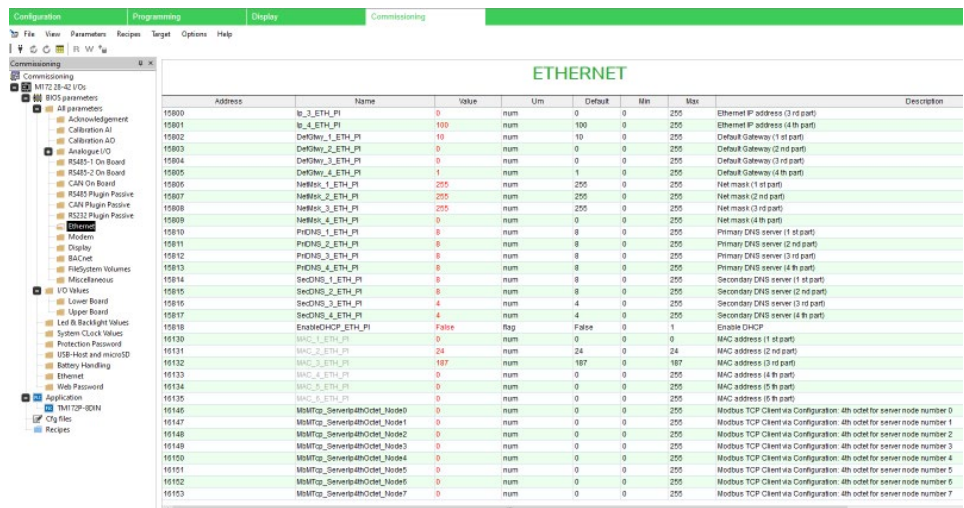
A PLC reboot is required to update the IP settings of the Server Nodes.

Below the new parameters in BIOS parameters\All parameters\Ethernet folder

Address	Name	Value	Unit	Default	Min	Max	Description
15800	Ip_1_ETH_PI	0	num	0	0	255	Ethernet IP address (1 st part)
15801	Ip_4_ETH_PI	100	num	100	0	255	Ethernet IP address (4 th part)
15802	DfGtwy_1_ETH_PI	10	num	10	0	255	Default Gateway (1 st part)
15803	DfGtwy_2_ETH_PI	0	num	0	0	255	Default Gateway (2 nd part)
15804	DfGtwy_3_ETH_PI	0	num	0	0	255	Default Gateway (3 rd part)
15805	DfGtwy_4_ETH_PI	1	num	1	0	255	Default Gateway (4 th part)
15806	NetMask_1_ETH_PI	255	num	255	0	255	Net mask (1 st part)
15807	NetMask_2_ETH_PI	255	num	255	0	255	Net mask (2 nd part)
15808	NetMask_3_ETH_PI	255	num	255	0	255	Net mask (3 rd part)
15809	NetMask_4_ETH_PI	0	num	0	0	255	Net mask (4 th part)
15810	PHDNS_1_ETH_PI	8	num	8	0	255	Primary DNS server (1 st part)
15811	PHDNS_2_ETH_PI	8	num	8	0	255	Primary DNS server (2 nd part)
15812	PHDNS_3_ETH_PI	8	num	8	0	255	Primary DNS server (3 rd part)
15813	PHDNS_4_ETH_PI	8	num	8	0	255	Primary DNS server (4 th part)

15814	SecDNS_1_ETH_PI	8	num	8	0	255	Secondary DNS server (1 st part)
15815	SecDNS_2_ETH_PI	8	num	8	0	255	Secondary DNS server (2 nd part)
15816	SecDNS_3_ETH_PI	4	num	4	0	255	Secondary DNS server (3 rd part)
15817	SecDNS_4_ETH_PI	4	num	4	0	255	Secondary DNS server (4 th part)
15818	EnableDHCP_ETH_PI	False	Flag	False	0	1	Enable DHCP
16130	MAC_1_ETH_PI	0	num	0	0	0	MAC address (1 st part)
16131	MAC_2_ETH_PI	24	num	24	0	24	MAC address (2 nd part)
16132	MAC_3_ETH_PI	187	num	187	0	187	MAC address (3 rd part)
16133	MAC_4_ETH_PI	0	num	0	0	255	MAC address (4 th part)
16134	MAC_5_ETH_PI	0	num	0	0	255	MAC address (5 th part)
16135	MAC_6_ETH_PI	0	num	0	0	255	MAC address (6 th part)
16146	MbMTcp_Server4thOctet_Node0	0	num	0	0	255	Modbus TCP Client via Configuration: 4th octet for server node number 0
16147	MbMTcp_Server4thOctet_Node1	0	num	0	0	255	Modbus TCP Client via Configuration: 4th octet for server node number 1
