**MTN6725-0001 KNX DALI-Gateway IP1 - Firmwareupdate 3.1 Release 10  
Release Note****Topic**

This application note describes the process for updating a device to firmware version 3.x.x by means of the DaliControl e64 Update Tool.

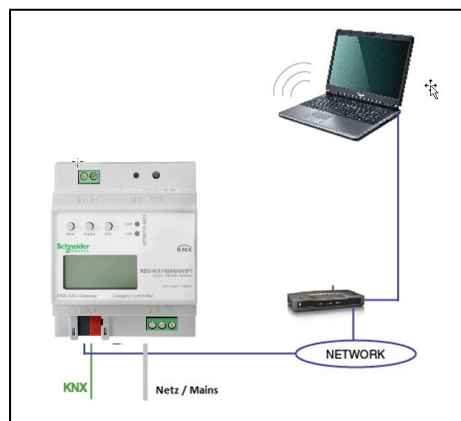
The firmware is updated via IP. The device therefore needs to be integrated into an IP network. Once the power supply is connected, the gateway is assigned an IP address either via DHCP or via manual address assignment in the ETS. To see the IP address, go to menu item “network” on the device display. You will need the IP address for the subsequent update process. The actual update is performed via a PC that is connected to the network.

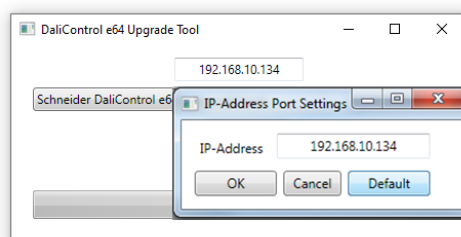
To start the update, enter the IP address of the device that you would like to update. Double-click on the displayed IP address (here 192.168.10.134) to open the entry field.

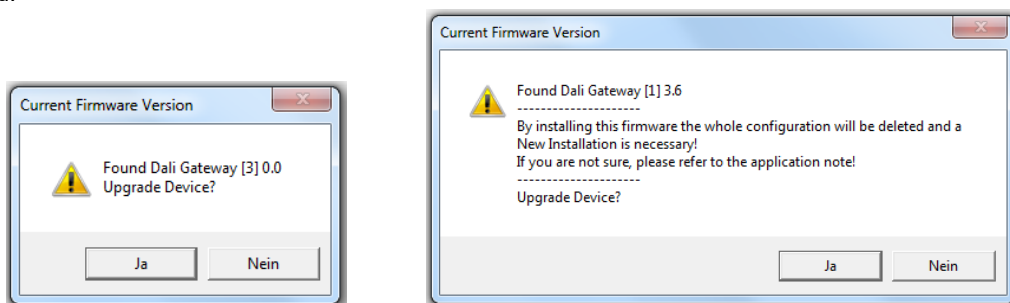
The update tool first checks the current firmware version of the Dali gateway and informs the user via an information window of the version that has been used up to now.

If you select “Unconditional” update, a further message appears in the window warning the user that the configuration data will be deleted.

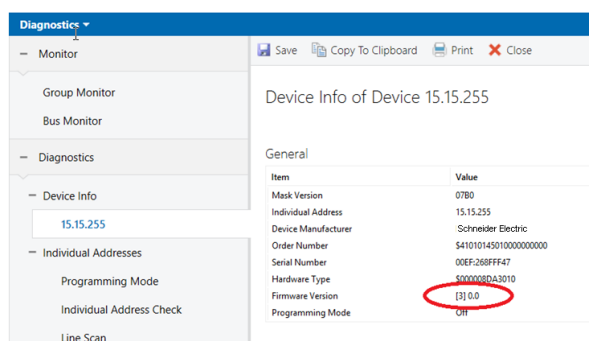
After an acknowledgement, the firmware data will be transferred to the device memory via FTP. A progress indicator informs about the current status of the transfer. Once the update files have been successfully transferred, the device is automatically re-set.

After the reset the device starts with the new firmware version.

The device display only shows the first two parts of the version (not the revision), e.g. Vers. 3.0. The full firmware version is available via the device info in the ETS.

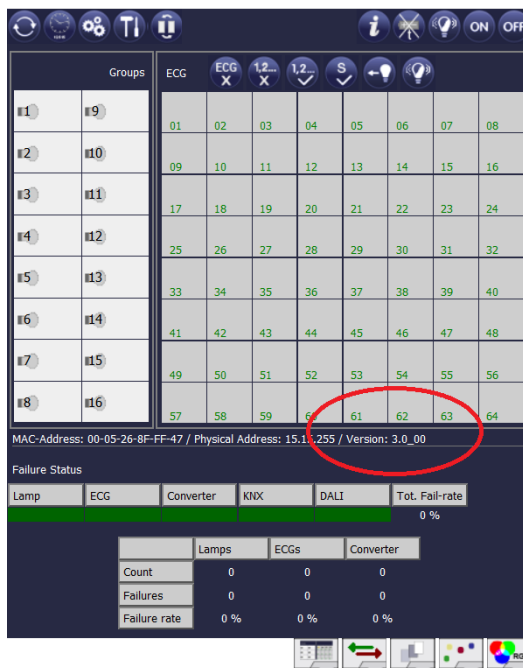
Alternatively, you can also check the current firmware version on the device website. The text box at the bottom of the ECG field displays the current firmware version in addition to the MAC address and the physical address of the device:
