KNX DALI-Gateway Basic REG-K - Firmwareupdate 0.2 Release 8
Release Note

This application note describes the procedure for updating a device to a new firmware version.

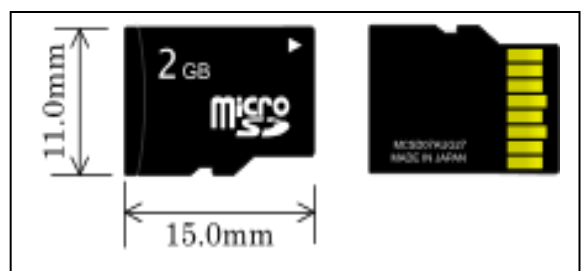
An update is only possible if the SD card has the FAT32 format. Most cards today are sold with the formatting FAT by default. It is therefore necessary to change the format of the card to FAT32 first.

Simply use any Windows File –Explorer to change the format.

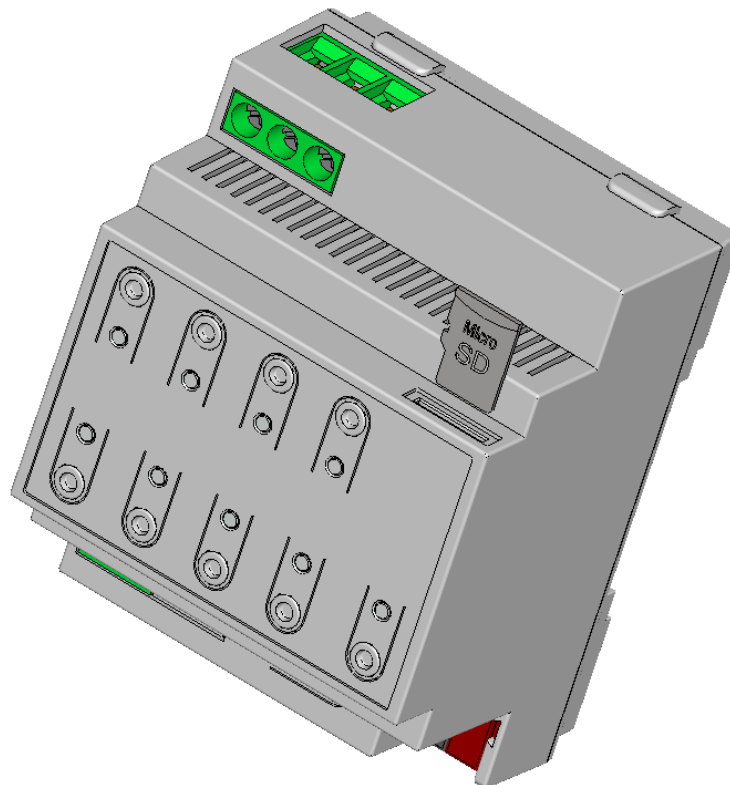
For update purposes, the DALI Gateways Basic are equipped with an SD card slot in the top right-hand corner. On delivery the opening of the slot is covered with an adhesive label. To insert a card, please carefully remove the label.

After the label has been removed, carefully insert the SD card into the disconnected gateway in such a way that the row of contacts points downwards and the recess in the card points towards the left. Please make sure to insert the card straight into the slot without any angle or bend. You will notice a slight pressure when the contact row has snapped into place.
