MUKITY CENTRE

Commissioning rooftop units in a community center with EcoStruxure™ Building Advisor*.

Community Center - New Jersey, USA

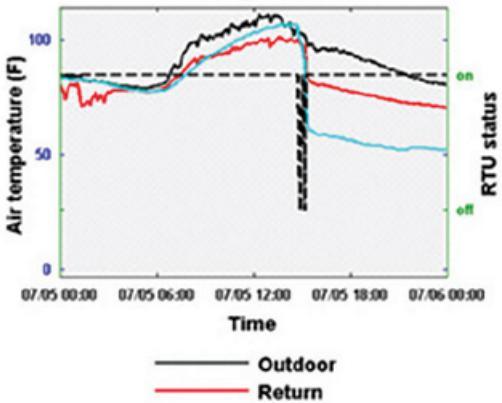
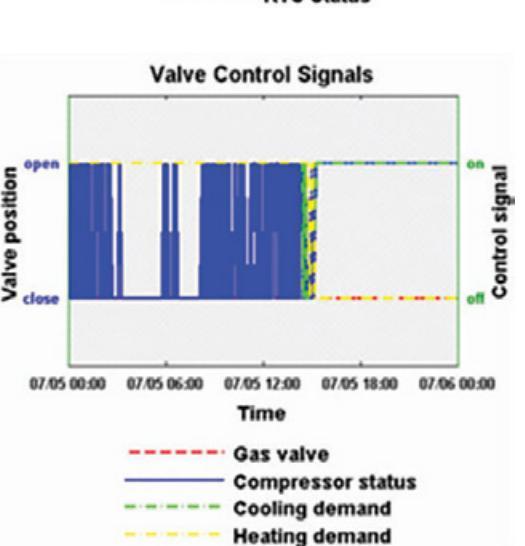
Supply ----- RTU Status

Figure 1: Temperatures and status points from the RTU with the cycling compressor on the day it was fixed. A little after midday, the compressor status stops cycling on and off, and the RTU supply temperature, which had been over 100 degrees, drops.

Short- cycling RTU Compressor

Challenge: One of the RTU compressors was found to be constantly short cycling when in operation. Issues with compressor cycling include increased compressor wear and premature equipment replacement, with constant starting and stopping, and comfort issues as cycling issues make it harder to control the supply air temperatures.

Solution: The compressor cycling was investigated and resolved when a faulty ground wire was fixed. The Bottom Line This facility earned 23 percent ROI from commissioning its rooftop units. Annual projected savings are more than $$5,000 \ (\in 3,800)$. Air Temperatures
